The Mars Climate Sounder In-Flight Positioning Anomaly

Bruno M. Jau* and David Kass**

Abstract

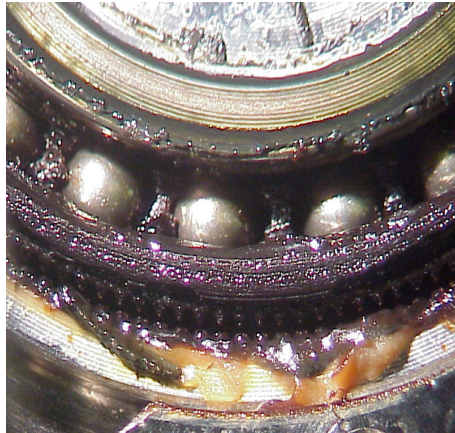
Figure 7: Close up View of Mechanical Components after the Life Test

Fig. 7 shows a close up picture of the harmonic drive, taken after the life test: No mechanical wear could be detected at any mechanical parts, nor was there any graceful degradation evident, which would have expressed itself, for instance, by substantial increases in backlash. But the lube's color had changed from brown to black in the engagement zones between gear teeth and in the bearings. Chemical analyses,

however, revealed that lube samples taken from inside the engagement zone had retained their lubricating capabilities. The joint thus maintains its full capabilities.

The overall conclusion based on life test results (for life test conditions), is that the joint demonstrated its capability to survive the required mission error free, pointing away from a mechanical cause for the anomaly: The life test joint is still being used on occasion today, proving its mechanical integrity and the lube's lubrication capabilities time and time again. It runs error free, provided it receives the proper electrical input signal and current.

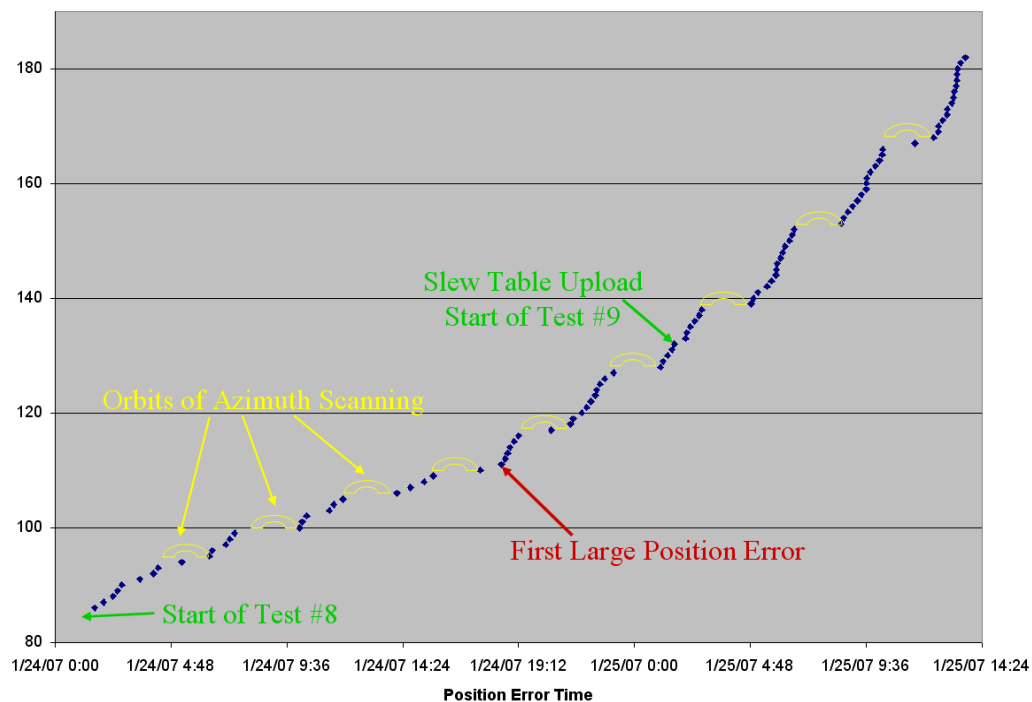
Figure 10: Error Rate in Late January Testing

The results are shown in Fig. 10, plotting the time of the error versus error number. The yellow crescents are the orbits with azimuth scanning. All of the errors during the azimuth orbits are associated with elevation scans. Part way through, it was decided to proceed with the next test (test #9) and remove the last difference between the two actuators by overwriting the elevation slew table with the azimuth table.

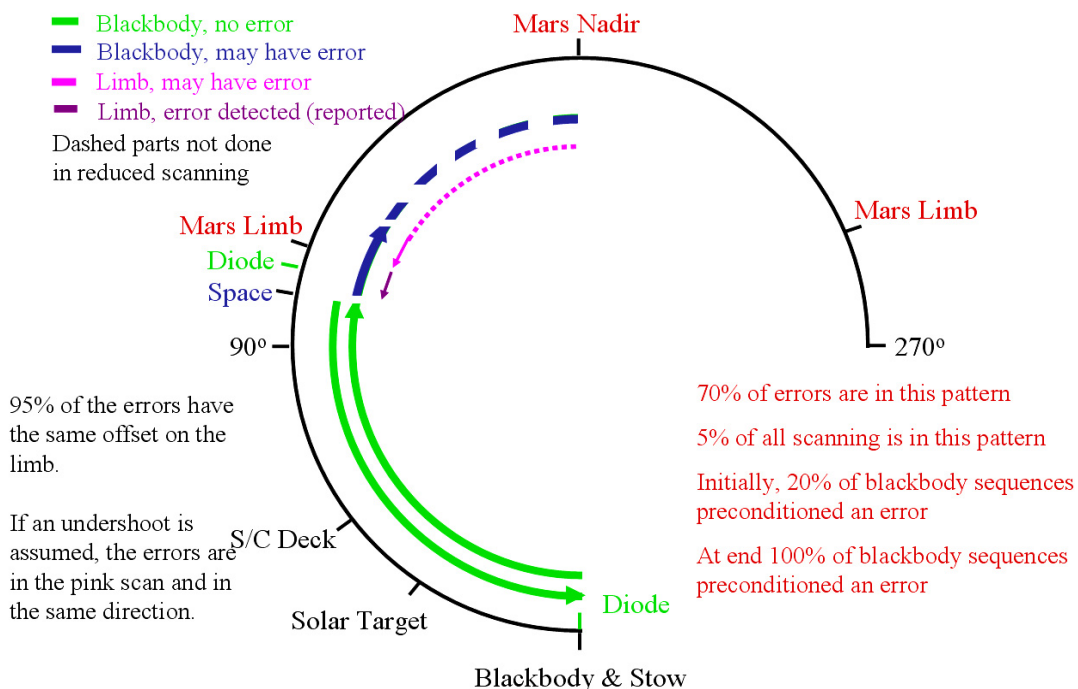
Figure 11: Blackbody then Limb Error Pattern

The cause of this preconditioning is not understood. Initially, 20% of the black body sequences preconditioned an error. When the errors were the most frequent, all black body sequences

preconditioned a position error. Extensive analysis of the MCS software, electronics and mechanical assembly, has failed to point out any reason for such a preconditioning to occur.

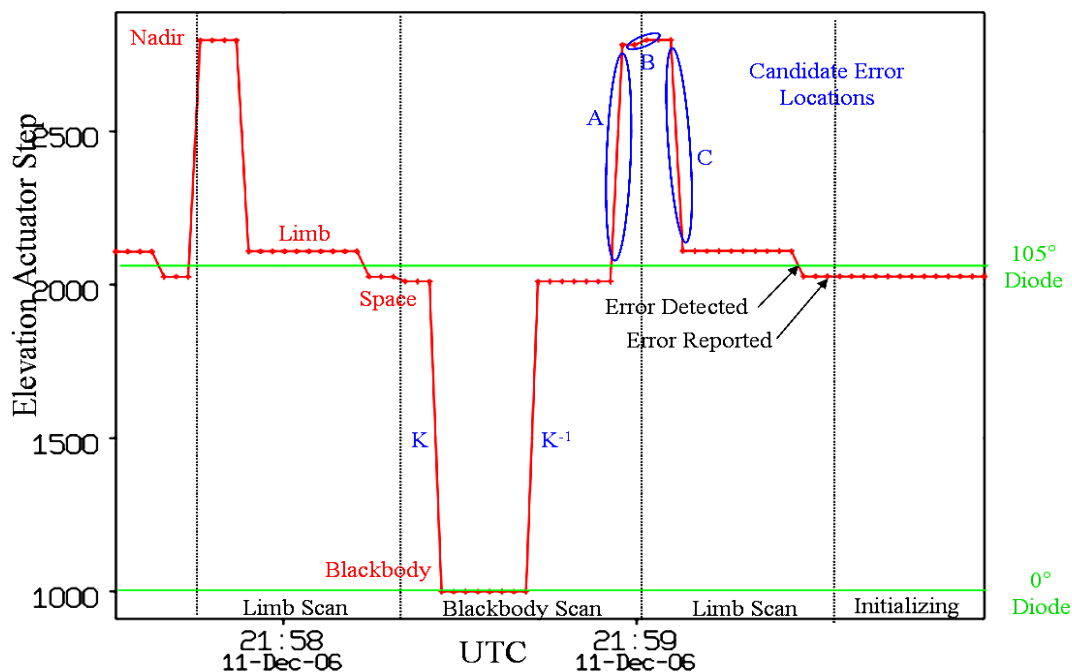
Figure 12: Slews Implicated in a Typical Position Error

While four potential root causes have not been completely eliminated, none appear to be the answer. None of them matches all observed or anticipated behavior of the hardware. All have major issues that would be sufficient to eliminate them from consideration.

It also should be noted that none of the potential error sources could explain the probable overshoots. It is very difficult to generate sufficient un-commanded movement in the motor to create a 4-step overshoot. While the motor controller could do so, the same software, firmware, and hardware are acting as motor controller for both actuators. Thus if it generates overshoots, it would do so for both actuators. Detailed independent reviews and extensive testing of the motor controller has not shown any propensity to generate overshoots.
